[Docket No. FAA-2011-0450; Directorate Identifier 2011-CE-010-AD; Amendment 39-16758; AD 2011-15-11]

Airworthiness Directives; Cessna Aircraft Company (Cessna) Models 337, 337A (USAF 02B), 337B, 337C, 337D, 337E, T337E, 337F, T337F, 337G, T337G, M337B, F 337E, FT337E, F 337F, FT337F, F 337G, and FT337GP Airplanes

2011-15-11 Cessna Aircraft Company: Amendment 39-16758; Docket No. FAA-2011-0450; Directorate Identifier 2011-CE-010-AD.

Appendix 1 to AD 2011-15-11

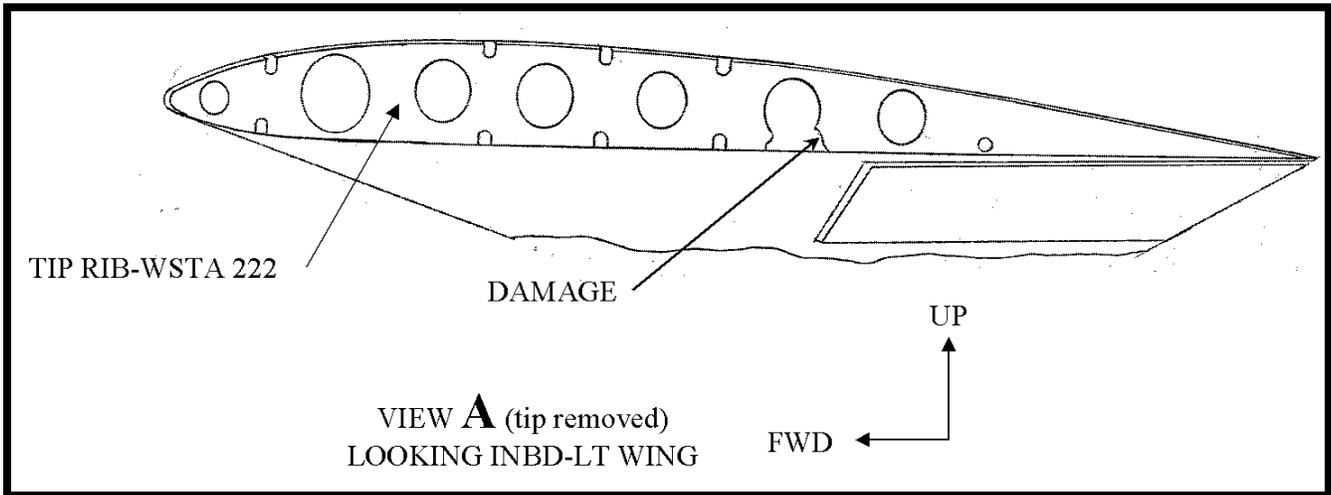
Figure 2

- (10) Inter-rivet buckling of the stringers attached to the upper surface skin, outboard of the fuel tank access covers (See View F, Figure 7).
- (11) Inspect rib at WSTA 222 for damage. Trimming of the rib may have been done to allow installation of fuel lines (See View A, Figure 2). Repair in accordance with AC 43.13-1B, Chapter 4, paragraph 4-58(g) and Figure 4-14, or by using another FAA-approved method that restores equivalent strength of the wing rib.

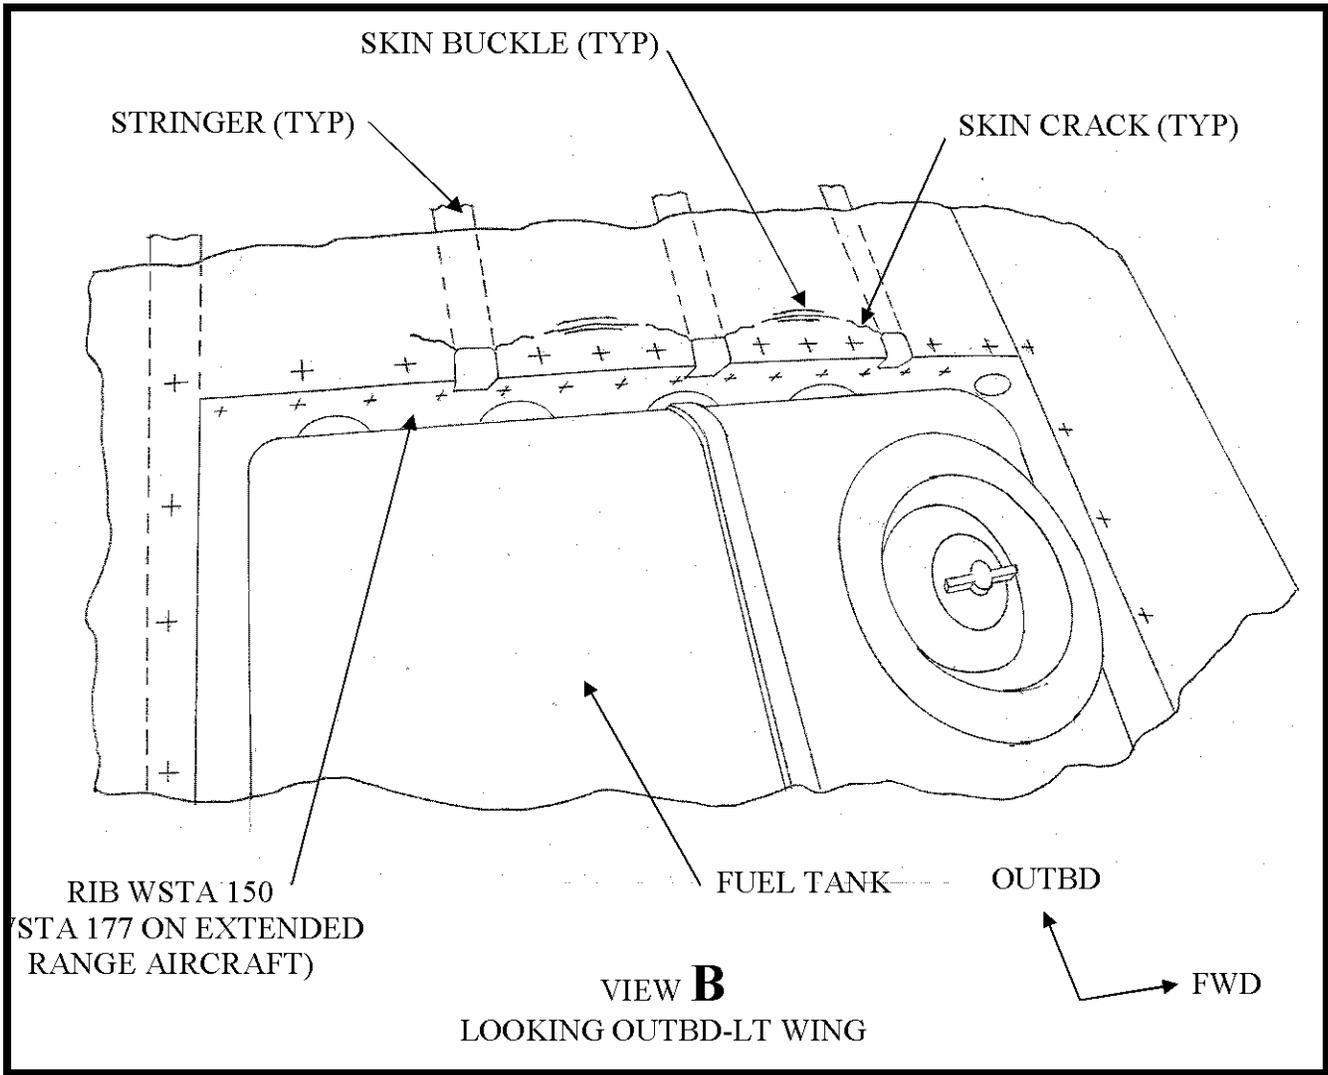
Figure 3

- (1) Wrinkles in upper wing skins, from the outboard edge on the fuel tank access covers (WSTA 150 or 177) to the WSTA 222 (See View B, Figure 3).
- (2) Wrinkles in the upper wing skins from WSTA 55 to 66, adjacent to the booms (See View E, Figure 6).

- (3) Cracking of the upper wing skins. Pay particular attention to any wrinkles, the radius between stiffeners at WSTA 150 (under fuel tank covers), and unreinforced access holes (See View B, Figure 3).

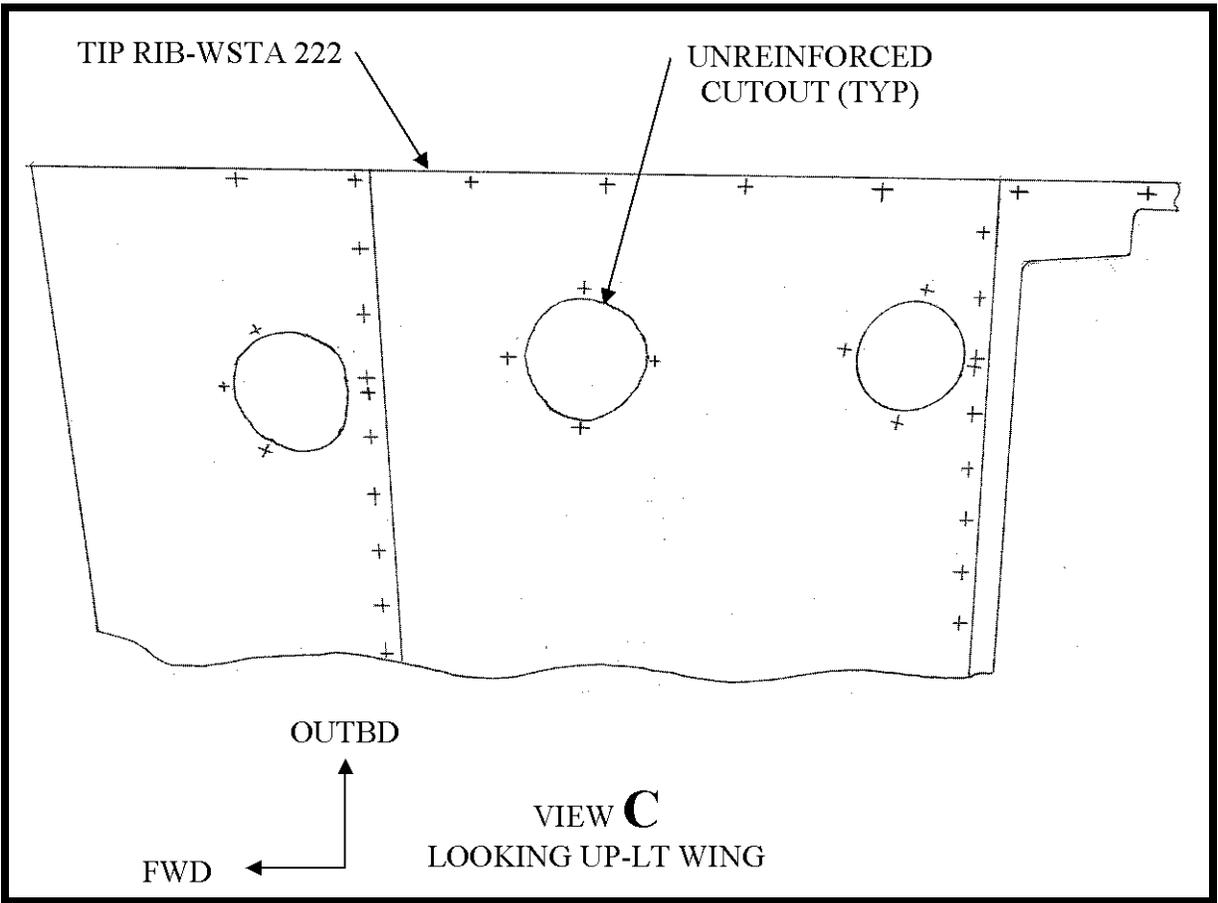
Figure 4

- (13) Inspect wing skins for unreinforced cutouts. (See View C, Figure 4).
- (14) Inspect the upper spar cap horizontal flanges for open holes (See View D, Figure 5).
