[Docket No. FAA-2011-0450; Directorate Identifier 2011-CE-010-AD; Amendment 39-16758; AD 2011-15-11]

Airworthiness Directives; Cessna Aircraft Company (Cessna) Models 337, 337A (USAF 02B), 337B, 337C, 337D, 337E, T337E, 337F, T337F, 337G, T337G, M337B, F 337E, FT337E, F 337F, FT337F, F 337G, and FT337GP Airplanes

2011-15-11 Cessna Aircraft Company: Amendment 39-16758; Docket No. FAA-2011-0450; Directorate Identifier 2011-CE-010-AD.

Appendix 1 to AD 2011-15-11

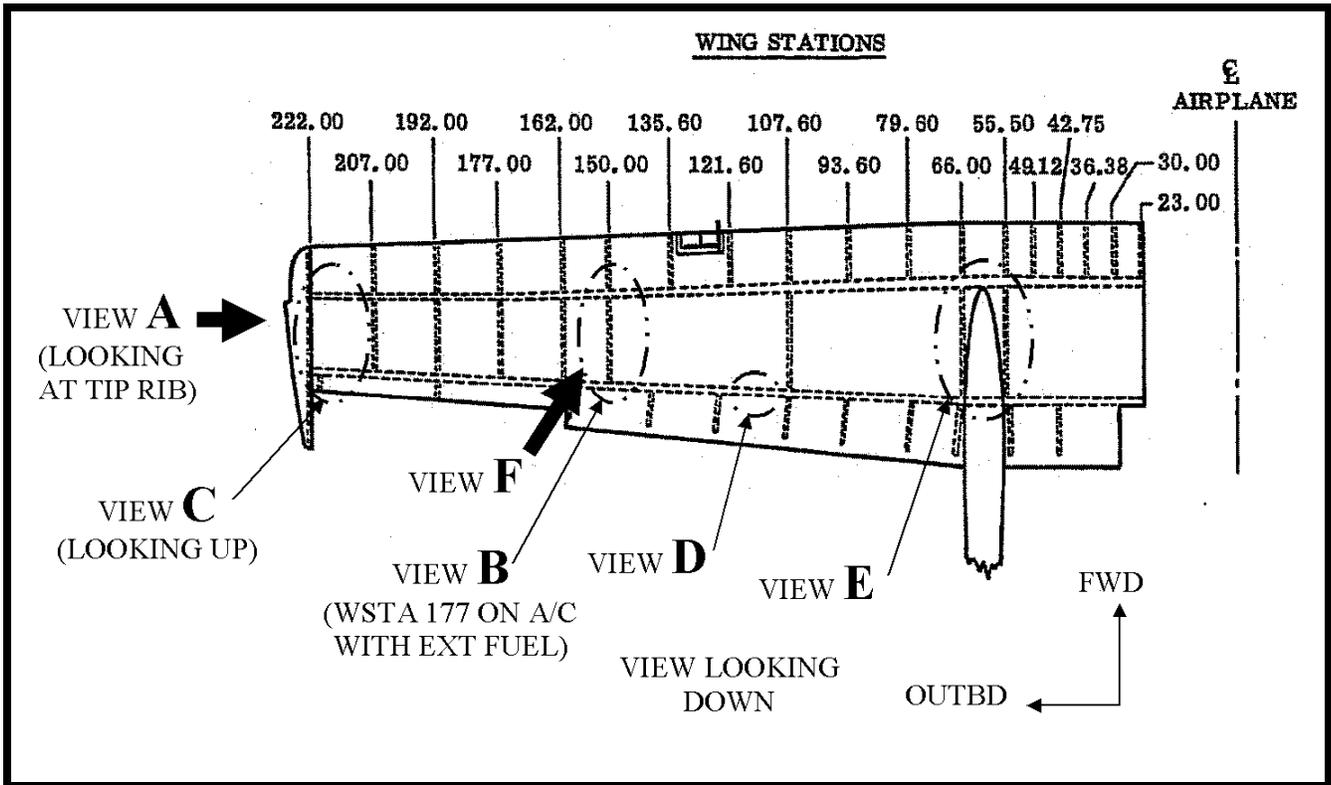
Figure 1

Perform a general and focused inspection of the wing for internal and external damage from wing station (WSTA) 23 to the wing tip. The general inspection must be performed in accordance with 14 CFR 43.15(c), using a checklist that includes at least the scope and detail of the items contained in Appendix D of 14 CFR part 43. The focused inspection must include the items listed below. Remove all wing access panels to conduct the inspections. Do these inspections following the manufacturer's service information and any other appropriate guidance, such as FAA Advisory Circular (AC) 43.13-1B Acceptable Methods, Techniques, and Practices—Aircraft Inspection and Repair. AC 43.13-1B can be found at <http://rgl.faa.gov/>.
